MTL TR 89-90

# FAILURE ANALYSIS OF A MISSILE LOCKING HOOK FROM THE F-14 JET

VICTOR K. CHAMPAGNE, Jr. and GARY WECHSLER  
MATERIALS TESTING AND EVALUATION BRANCH

September 1989

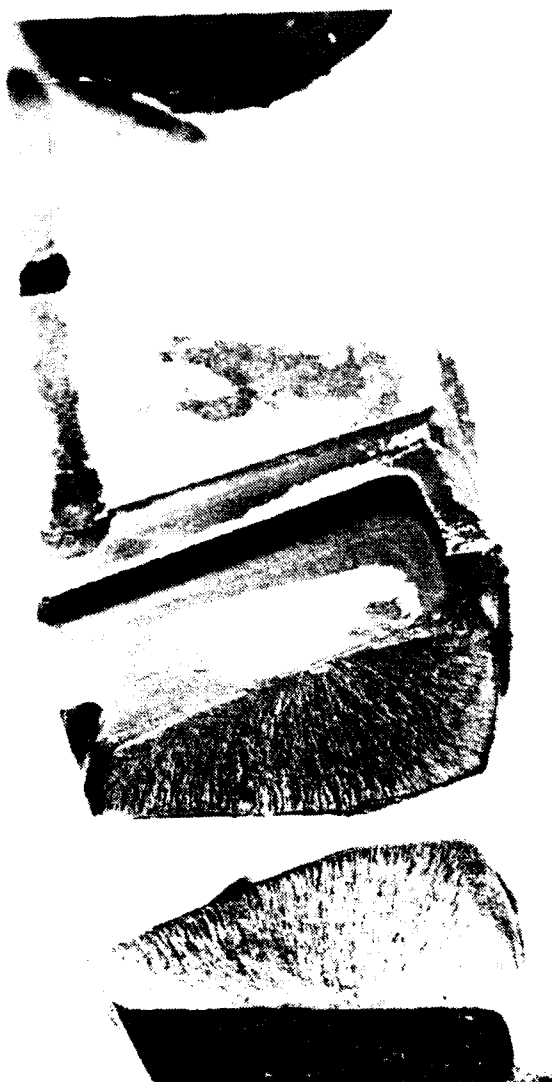
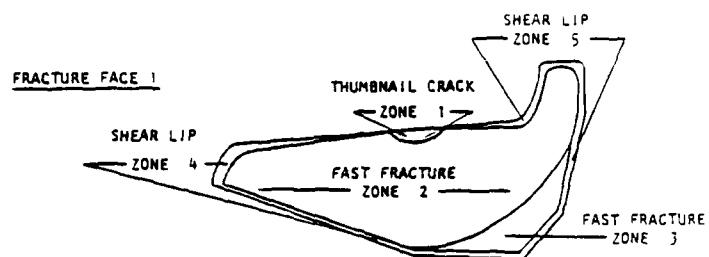
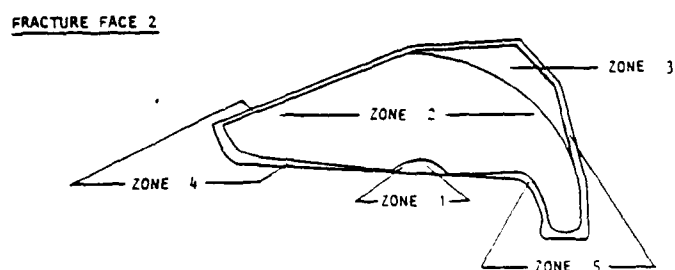
Figure 2 shows the area of concern on the missile hook, at low magnification. The failure occurred along the lower radius of the machined lip. Radial marks were easily distinguishable on the fracture faces. These lines resulted from the intersection and connection of fractures propagating at different levels. The crack initiation site was identified when these lines were traced back to the point of convergence (refer to Zone 1). Some of the outside edges of the fracture faces contained shear lip zones which were characterized by their gray, silky appearance. At the crack origin, a typical "thumbnail" crack could be seen extending outward (refer to Zone 1) which suggested that an older crack may have existed before final, fast fracture occurred. This was later verified by further examination.

Another notable feature of the fracture surface was an area that resembled a "quarter moon" (refer to Zone 3). Scanning electron microscopy (SEM) was utilized to obtain additional metallurgical information from this region as well as the remaining fracture surface. These results are included as part of the fractographic analysis of this report. Fracture Face 2 appeared to have less corrosion and surface debris than Fracture Face 1. It was later discovered that Fracture Face 2 was recovered from the deck of the aircraft carrier after the failure occurred and placed in storage, protecting it from the elements. Fracture Face 1, however, was still attached to the aircraft and was removed at a much later date. The salt water environment caused additional corrosion to take place on the unprotected fracture surface.

Figure 2. Macrograph of the failed missile hook showing the fracture faces. The schematic to the right identifies different regions of the fracture which were examined.

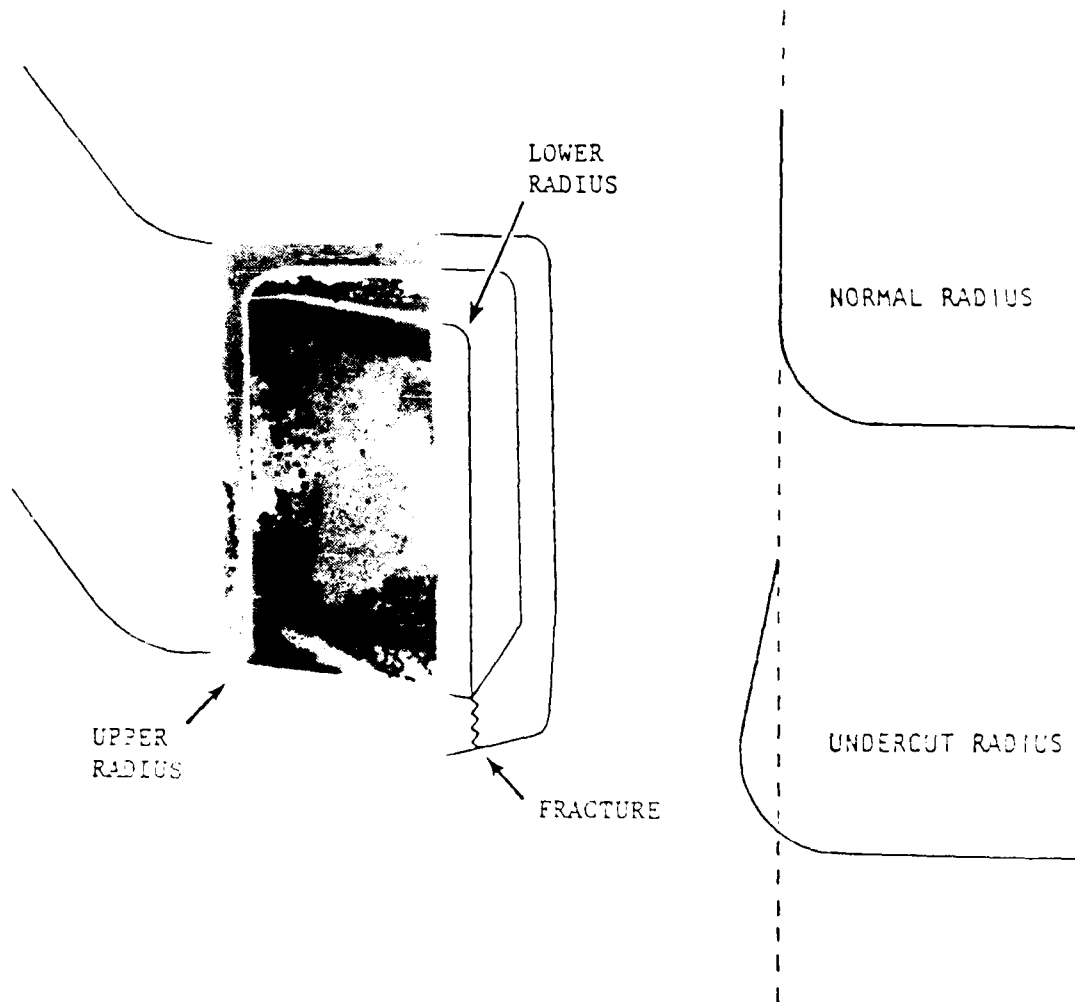
The upper radius of the machined lip, as shown in Figure 7, was measured and found to be approximately 0.015. The engineering drawing of the missile hook, as depicted in Figure 5, specified a radius of 0.02 to 0.03. This measurement might serve as an indication that the lower radius was also machined slightly sharper than specifications allowed, since both radii are continuations of each other, having the same specified measurements and tolerance ranges. The lower radius, where the fracture originated, could not be measured accurately because the material had been deformed in this area as a result of the failure.

Another notable feature of the radius along the machined lip was the fact that it was undercut, as revealed in Figure 7. The schematic located adjacent to Figure 7 illustrates this point. An undercut radius reduces the cross-sectional area of the load-bearing region, decreasing its strength. A sharp radius will serve as a stress concentration area and have a detrimental effect on the fatigue life of the component.

Figure 7 Macrograph showing the undercut radius of the missile hook, Mag. 3X.

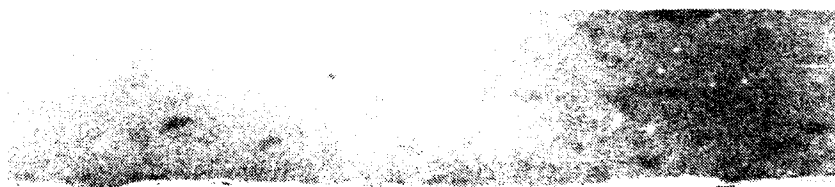
The material under investigation (300M steel) is susceptible to hydrogen embrittlement when heat treated to strength levels greater than 200 ksi.<sup>1</sup> The missile hook had a measured hardness range of HRC 56 to 58 which translates to an ultimate tensile strength of approximately 284 to 299 ksi. Consequently, concern was expressed over the extent of pitting that occurred near the crack origin, since the corrosion process can be a source of atomic hydrogen. In a corrosion cell, hydrogen ions can be reduced, producing hydrogen atoms and the subsequent formation of hydrogen molecules. If a sufficient amount of nascent hydrogen migrated into the steel, it could become embrittled and subject to premature cracking. Figure 11 shows regions adjacent to the fracture that contained pitting. The measured depth of attack on these specimens ranges from approximately 0.001 to 0.005 inches.

Figure 11. Macrographs of transverse cross sections taken prior to polishing that show pitting, Mag. 60X.

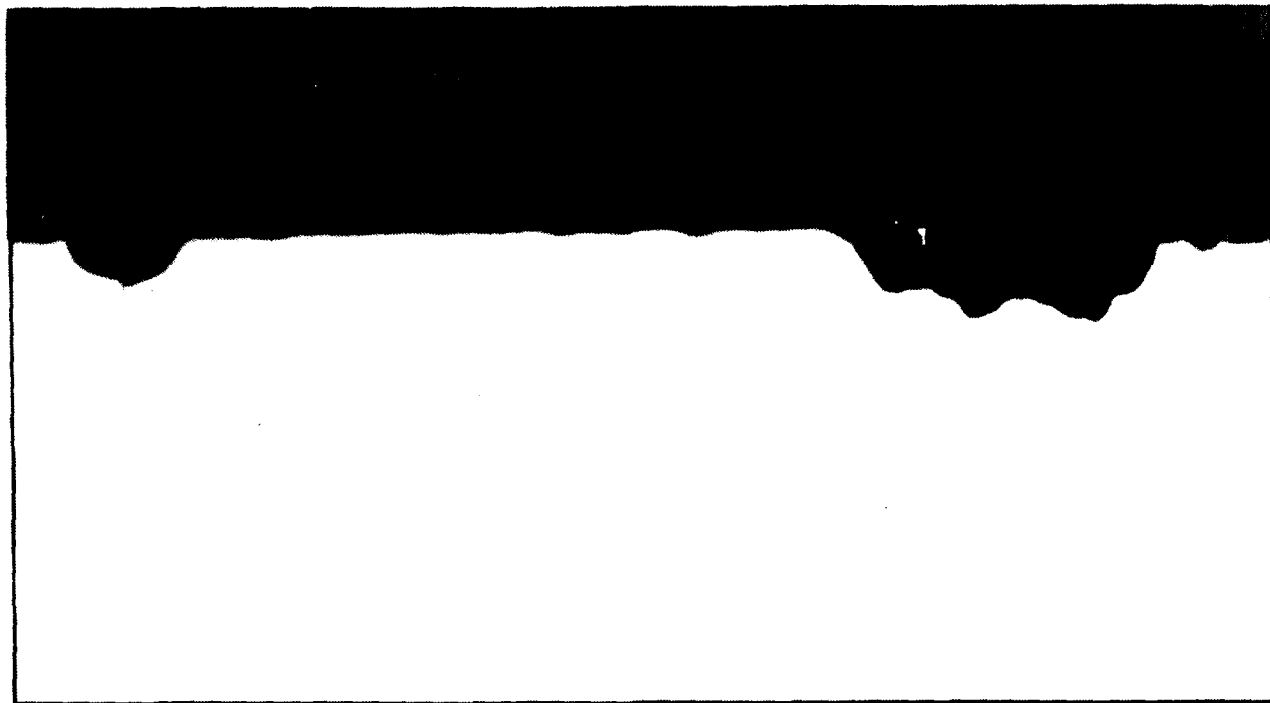
Pitting may also be detrimental to the useful service life of the component because the root of a pit is an area of high stress concentration where a fatigue crack could initiate and propagate. Figures 12 through 14 show transverse cross-sectional views of specimens in the as-polished condition that contained pits.

Figure 12. Micrograph revealing evidence of pitting attack. Pit depth is 0.002 to 0.005 inches, Mag. 100X.

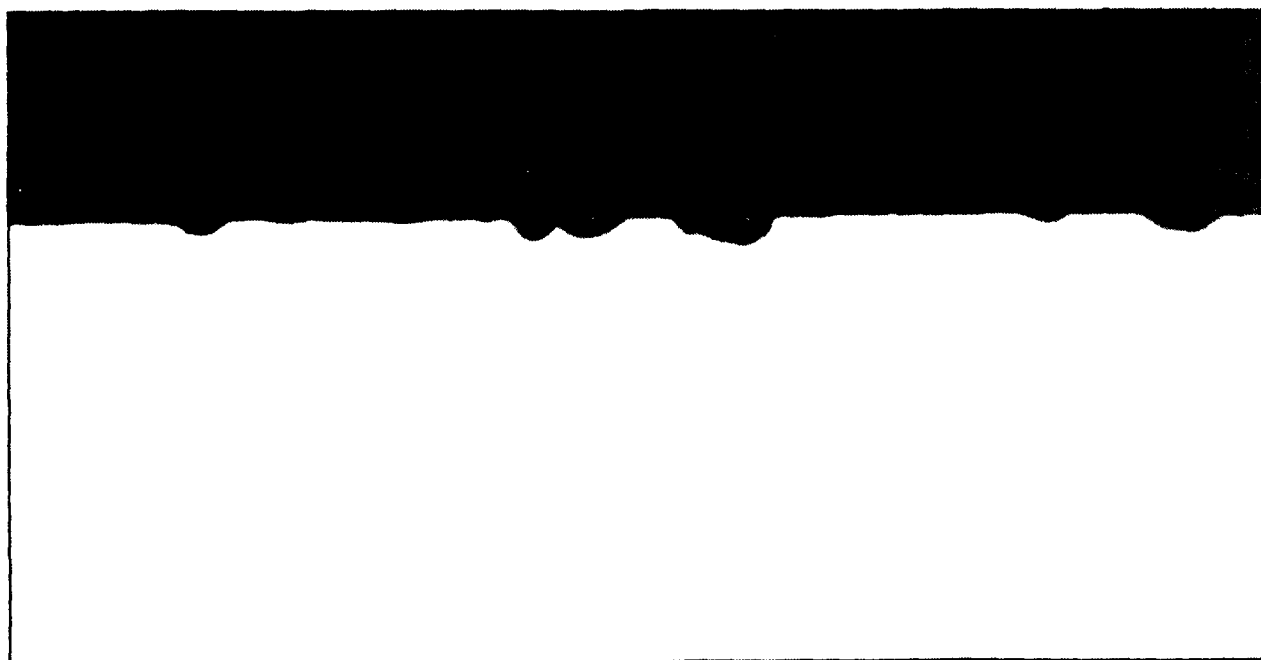
Figure 13. Micrograph showing a number of isolated pits. Maximum pit depth is 0.002 inches, Mag. 100X.

The amount of pitting found on the surface near the fracture varied. Some areas contained pits that were isolated, as shown in Figure 13. Other regions developed pits that were so close together that they resembled a rough surface, as seen in Figure 14.

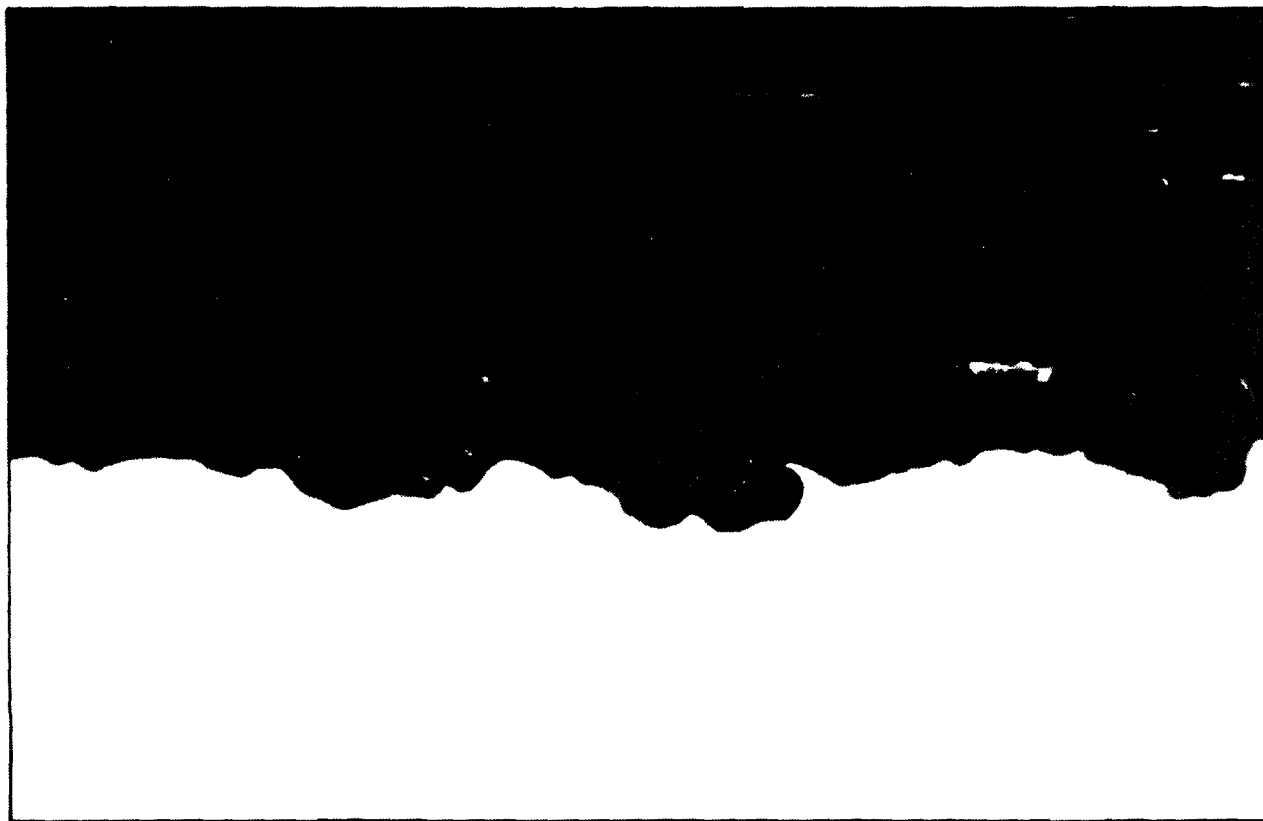
Figure 14. Micrograph of a region which contains extensive pitting damage, Mag. 100X.

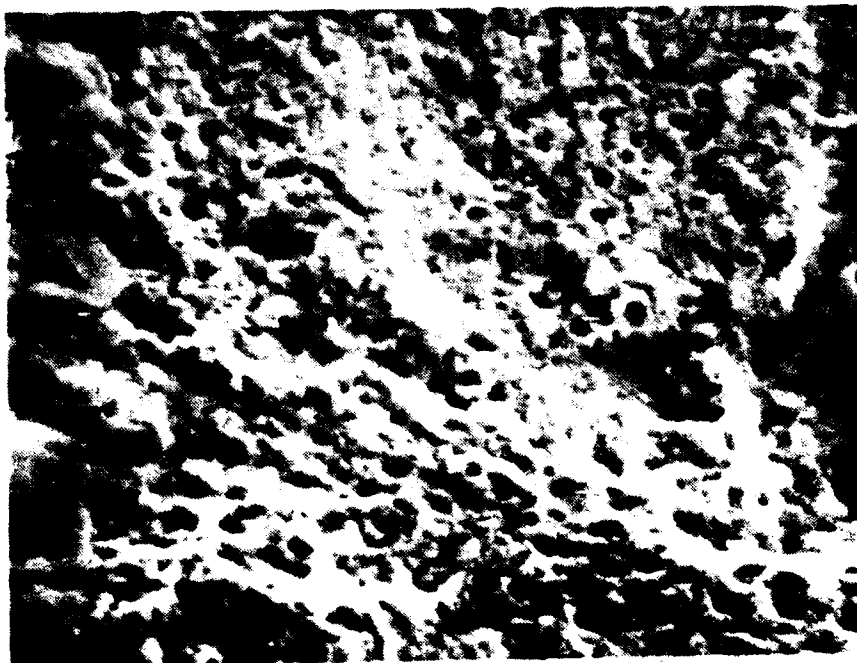
Corrosion was prevalent over the entire surface of the "thumbnail" crack region. In most of the locations observed with the SEM, it had inhibited conclusive fractographic interpretation of the failure mode. In areas that could be examined and characterized with some degree of certainty, Zone 1 was determined to have contained a ductile dimpled morphology, as indicated in Figure 19.

Figure 19. SEM fractograph of Zone 1 revealing a dimpled surface topography in regions that have not been obliterated by corrosion, Mag. 2000X.

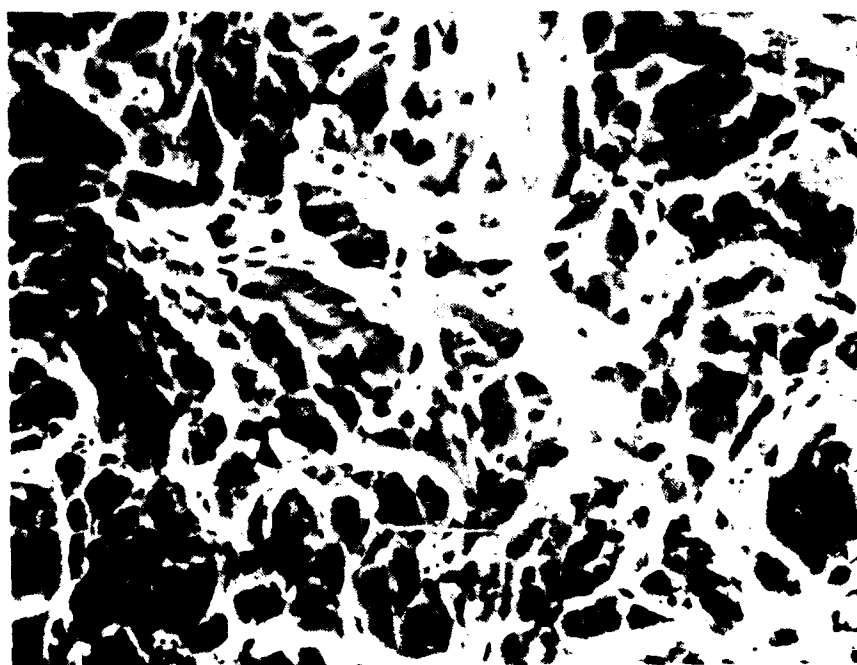
Further scanning electron microscopy was performed on the remaining fracture zones identified in Figure 2. The transitional region located between Zone 1 and Zone 2 was examined. Figure 20 is a representative SEM fractograph of that area. The surface morphology consisted of dimples with some evidence of tearing topography surface (TTS). The TTS fractures do not exhibit as much plastic deformation as a dimpled rupture, and may be the result of a microplastic tearing process.<sup>5</sup> Tearing topography surface is often observed along with well-defined dimples.

Figure 20. SEM fractograph of the transitional area between Zone 1 and Zone 2 showing evidence of tearing topography surface amidst ductile dimples, Mag. 2000X.

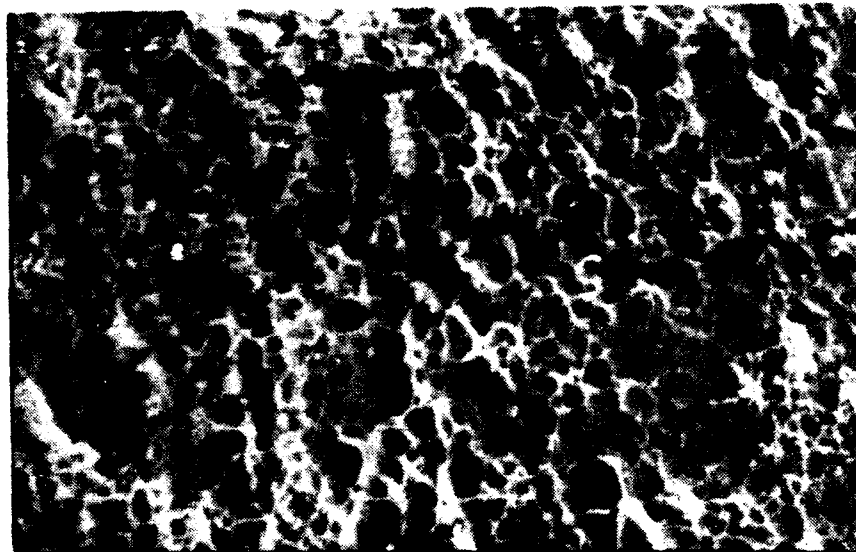
The surface topography of Zone 2 is represented by Figure 21. Well-developed conical equiaxed dimples indicative of microvoid coalescence can be seen in this figure. This type of fracture mode occurs under a *primarily uniaxial tensile stress* and is most commonly associated with an overload condition.

The area previously described as resembling a "quarter moon" was examined and labeled as Zone 3. This region was most likely the result of a brief interruption of the advancing crack front (such as a shift or a change in loading) which later resumed its course until final rupture occurred. The single progression mark that outlines Zone 3 remains as evidence supporting this conclusion. Zone 3 also contained a conical equiaxed dimpled surface, confirming that the fracture mode was similar to that of Zone 2, as depicted in Figure 21.

Figure 21. SEM fractograph representative of Zone 2 and Zone 3 showing a surface consisting of conical equiaxed dimples, Mag. 2000X.

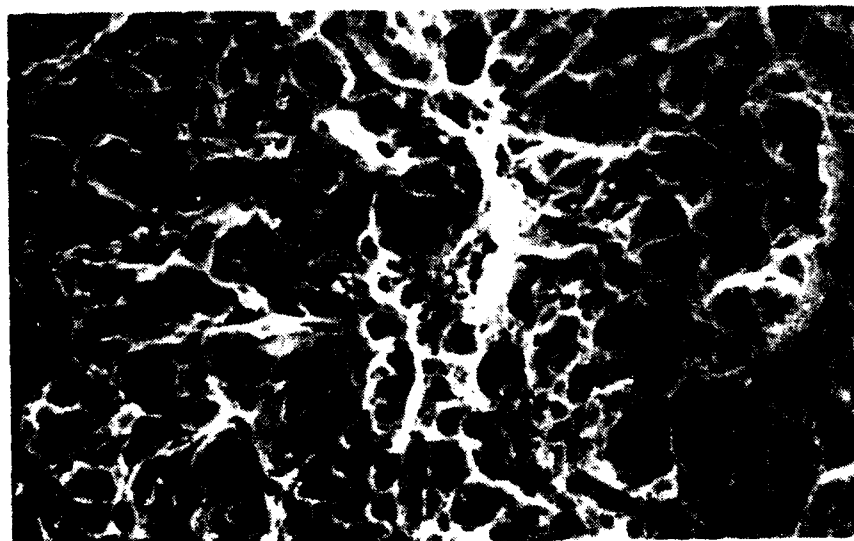
The fracture regions identified as Zones 4 and 5 were determined to be shear lips. These areas were the result of a stress change to macroshear, forming fractures approximately 45° to the plane of the fracture. Figure 22 reveals the surface morphology of these shear lip regions. Dimples which are directional can be seen in this SEM fractograph.

Figure 22. SEM fractograph containing slightly directional dimples indicative of Zone 4 and Zone 5, Mag. 2000X.

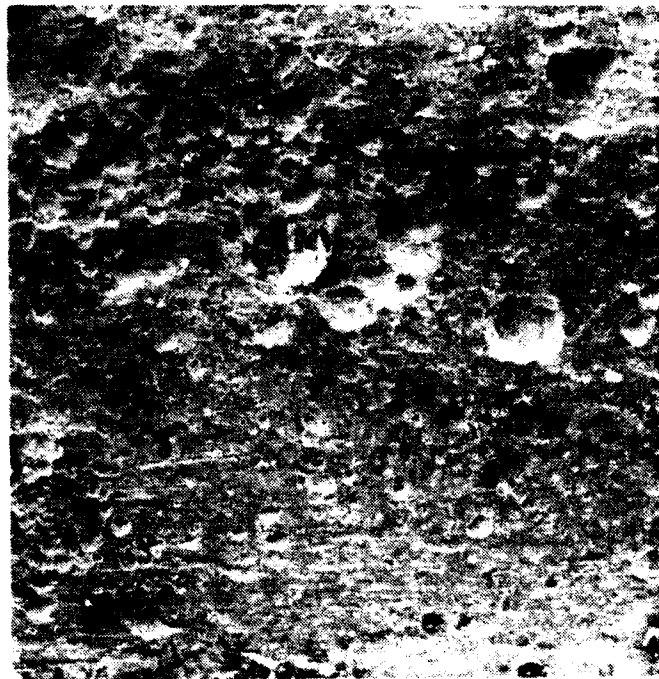
The surfaces adjacent to the fracture were also examined utilizing the SEM. Figure 23 is representative of many of the locations observed. The absence of a protective coating in these regions allowed extensive pitting to take place. Pits act as localized stress concentration areas and may initiate a crack. Figure 24 shows an example of how a crack initiated at the root of a corrosion pit.

Figure 23. SEM micrograph of the severely pitted surface adjacent to the fracture site, Mag. 100X.

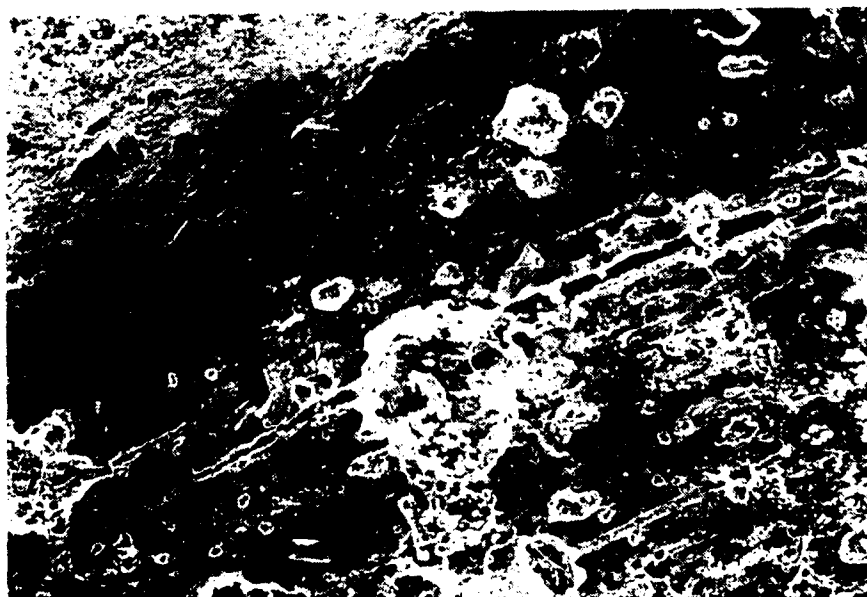
Figure 24. SEM micrograph of a crack that has initiated from the root of a corrosion pit located on the machined surface adjacent to the fracture, Mag. 250X.

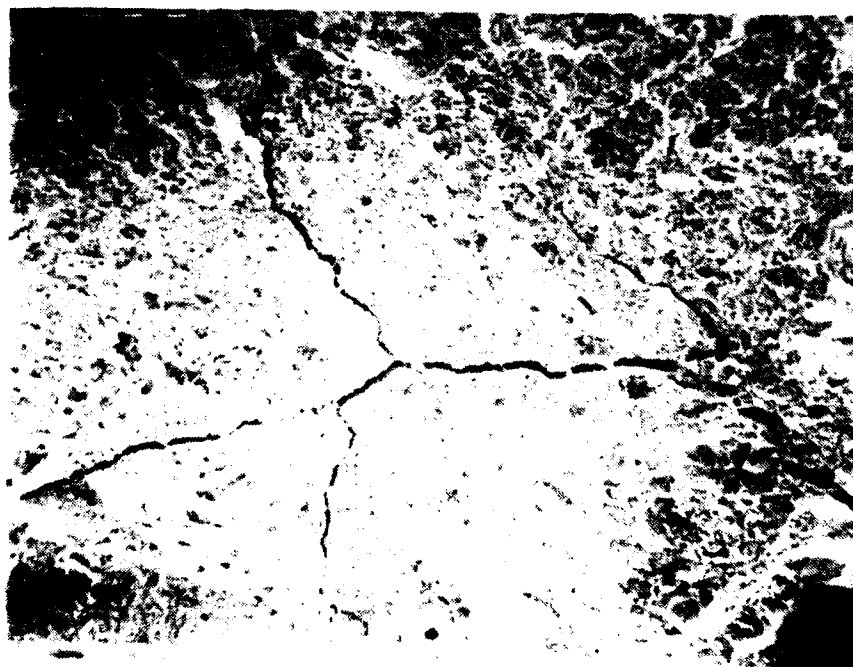
Figure 24 shows Fracture Face 1 after cleaning. The dark corrosion product indicative of Zone 1 is barely visible. However, extensive cracking had occurred, after only a brief period, as a result of the cathodic reaction which was the cleaning mechanism in this process. Many of the cracks had initiated at stress concentration areas (such as corrosion pits) along the surface. Single cracks that were virtually without branches were observed while, in other instances, cracks formed in multibranched river delta patterns. Figures 25 and 26 reveal a crack that had experienced branching.

Zone 1 was significantly damaged by the effects of the corrosion process which had left behind an irreconcilable topography in most areas. However, the surface morphology was found to consist of dimples in regions that could be accurately interpreted, as previously shown in Figure 19. The cleaning procedure utilized reaffirmed the fact that the material under investigation was very susceptible to hydrogen embrittlement.

Figure 26. SEM fractograph showing the cracked region outlined on Figure 25, at higher magnification, Mag. 260X.

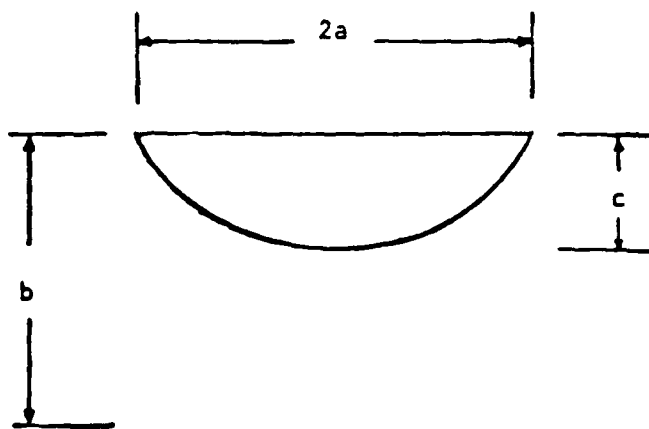
2. It was possible to measure the critical crack size from the failed component. This area had been previously identified as Zone 1 (see Figure 2) or the "thumbnail" crack region. The crack parameters and pertinent dimensions of the missile hook were obtained from measurements of the fracture surfaces, as shown in Figure 39.

2a = crack length = 0.25 in.  
 b = material thickness = 0.4 in.  
 c = crack depth = 0.035 in.

Figure 39. Crack parameters measured from the fracture surface.

In summary, since the calculated critical size (0.42") was greater than actual measurements of crack depth (0.35"), the material did not appear to exhibit the anticipated fracture toughness. The size of the crack that caused the failure should have been larger. Similarly, the value of  $K_{IC}$  (50.8 ksi) calculated for the observed conditions was lower than published values, which also supports this conclusion.
